IMPELLER UNBALANCE IDENTIFIED THROUGH CONDITION MONITORING

The asset under monitoring was an OH2 style pump driven by a 300 HP electric motor.

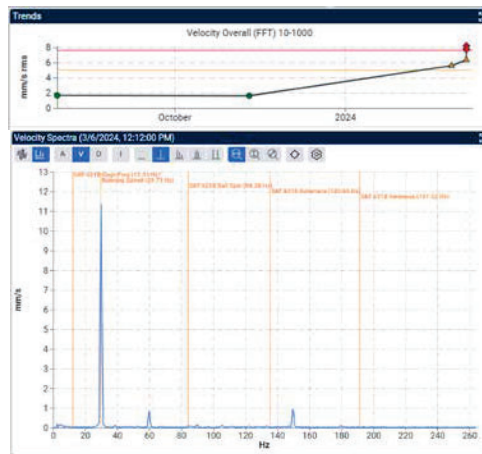
During routine scheduled condition monitoring, a significant increase in vibration was identified at both the pump drive-end and non-drive-end horizontal locations.

Vibration levels exceeded ISO 10816-7 alarm thresholds, indicating a risk of mechanical damage if left unaddressed.

During monthly analysis, Westpower reliability engineers identified abnormal vibration trends and escalated the issue for further investigation. Detailed spectral analysis was conducted to determine the likely fault mechanism before any intrusive work was undertaken.

Vibration spectra indicated a likely impeller unbalance condition. The amplitude levels and frequency characteristics aligned with unbalance signatures, prompting a recommendation for physical inspection.

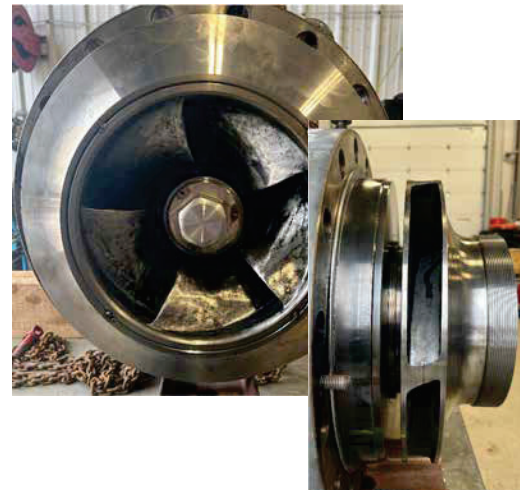
The pump was dismantled and the impeller visually inspected. It was found to be in excellent, near new condition, with no visible mechanical damage. Measured runouts were slightly above specification but insufficient to explain the elevated vibration levels.

The mechanical workshop identified that the impeller was 90 grams out of balance. Dynamic balancing was carried out to correct the condition before the component was returned to site.

Following collaborative discussions between Westpower reliability specialists and the site maintenance team, the decision was made to send the impeller to a local mechanical workshop for dynamic balancing to confirm or eliminate imbalance as the root cause.

After reassembly and recommissioning, vibration levels reduced significantly from 7.8 mm/s RMS to 1.4 mm/s RMS, returning the asset to within acceptable ISO limits and close to its established baseline.
